HOFFMAN HEIGHTS - AURORA, COLORADO RECONNAISSANCE SURVEY

Architectural & Historical Survey Report

Office of Archaeology & Historic Preservation CLG Project Number 08-09-011

Prepared By:
Hoehn Architects P.C.
50 Pennsylvania Street
Denver, Colorado 80203
(303) 282-3884
tkhoehn@mho.net
HAPC Project No. 0907

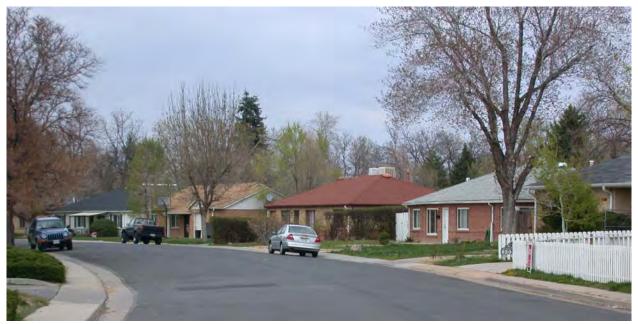
Figure 1.

The combination of non-linear streets and the variation in brick colors and roof forms in Hoffman Heights breaks the monotony possible in a typical subdivision.

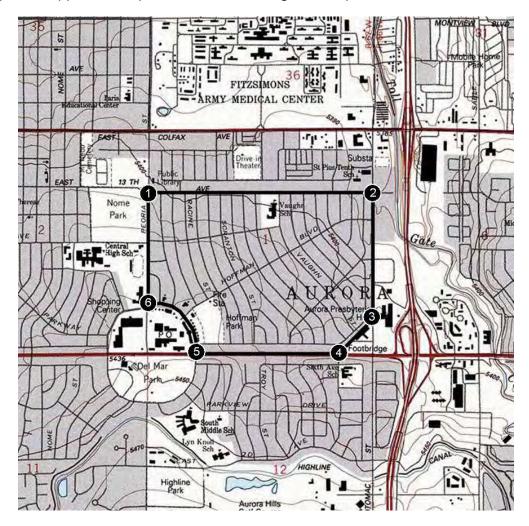
Figure 2.

The project area included in the Hoffman Heights Reconnaissance Survey is shown above on this map. The project area is located in the Sixth Principal Meridian, Township 4S, Range 67W, Section 1 (USGS Fitzsimons Quadrangle). The UTMs at the six locations on the map are as follows:

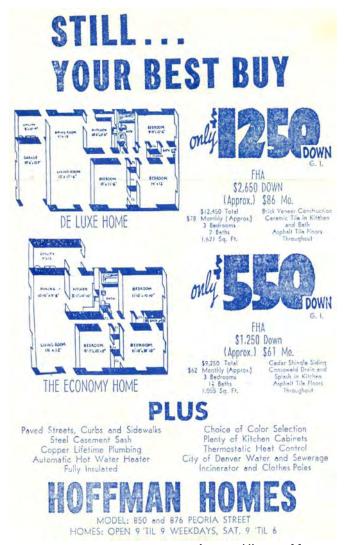
Figure 4.

Other variations in each house model were available, although not listed as "standard extras" and determined through on-site observations; one brochure for the Deluxe Brick Model indicated that ten different "styles" or elevation options were available to prospective buyers. Although illustrations or descriptions of these styles have not been located, on-site observations indicate these elevation options included a gable or hipped roof; a front wall gable or separate hipped roof at the end of the house over the garage or above the entry door; a single brick color (red or blonde) or a combination of the two brick colors on the Deluxe Brick Model; and an attached garage that was available in three positions relative to the front exterior wall of the house: recessed (as shown on the floor plan in Figure 4), projecting or flush with the house. Steel casement windows were provided in every house.

The Deluxe Brick Model was the most popular house built in Hoffman Heights. Based upon the reconnaissance survey, 940 of this model were constructed. The Deluxe Brick Model can be distinguished not only by its brick veneer, but also by an attached garage. A front entry door provides direct access to the living room, which is located at the end of the house adjacent to the garage. The living room and two of the three bedrooms have casement windows that face the street; the living room window is larger than the bedroom windows. (Refer to Figure 13 for an example of this model and to Figure 4 on page 11 for the floor plan.)

The Economy Frame and Shingle Model was the second most constructed house in Hoffman Heights. The survey results indicate that 586 of this model were built. The Economy Frame and Shingle Model was not available with an attached garage, but it contains three bedrooms and 1½ bathrooms. The siding originally installed on the house was asbestos shingle siding in a combed or smooth finish, according to field observations. Similar to the Deluxe Brick Model's floor plan, the economy version has a living room located at the end of the house that features a large picture window. The two smaller windows provide natural light and ventilation for the two bedrooms that face the street. (Refer to Figure 4 on page 11 for the floor plan and to Figure 14 for a photograph of this typical model.)

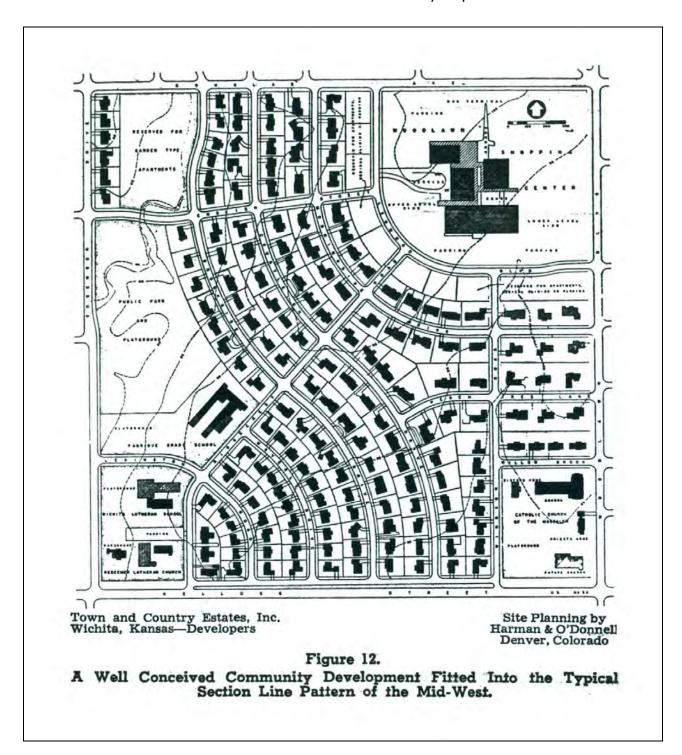
Figure 6.

<u>The Community Builders Handbook</u> also included this plan for a community development. The plan was designed for a section of land, similar in size to the Hoffman Heights subdivision in Aurora. A shopping center is shown in the northeast corner of the site, a school is located along the diagonal road that terminates at the shopping center, and churches were planned for the southeast and southwest corners of the development.

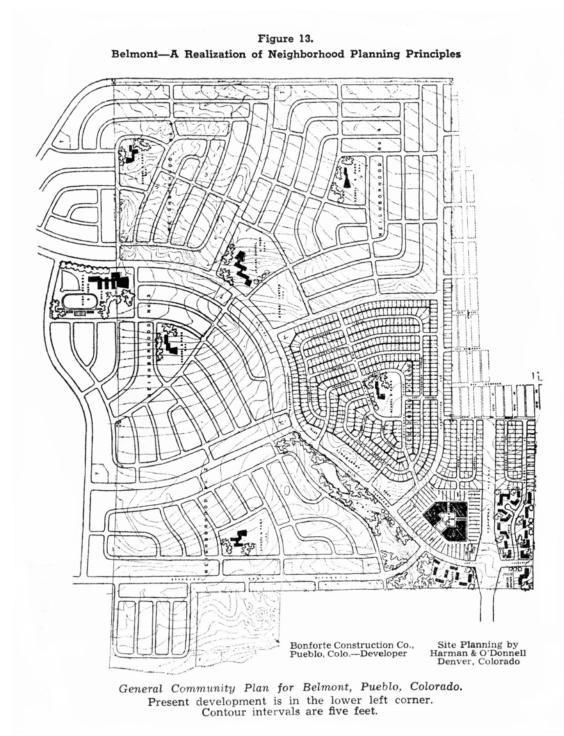
Figure 7.

Although not developed by Sam Hoffman, the Belmont Community Plan in Pueblo, Colorado, reflects the design principles that community builders like Hoffman were following for Post-World War II subdivisions. Note that the site plans for both this figure and the preceding one were prepared by Harman & O'Donnell, a Denver, Colorado-based planning firm established in 1946 with an international client base.

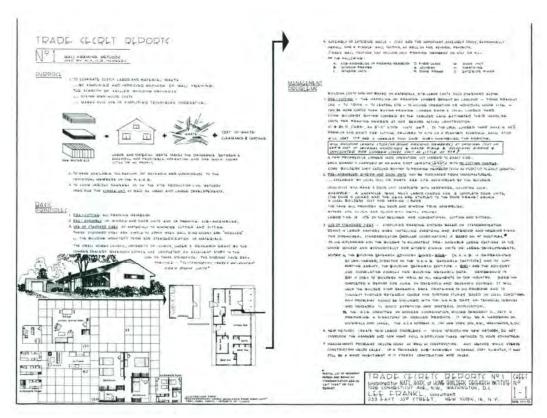
Figure 8.

development". The National Association of Home Builders' Research Institute published "Operation Trade Secrets" in 1952, which contained individual reports on construction techniques, including wall framing methods (Report No. 1) and trussed rafter construction (Report No. 2). The purpose of Report No. 1 included eliminating costly labor and material waste and to show various degrees of on-site production line methods used for the single housing unit as well as small and large developments. (Refer to Figure 8 for an excerpt from "Operation Trade Secrets".)

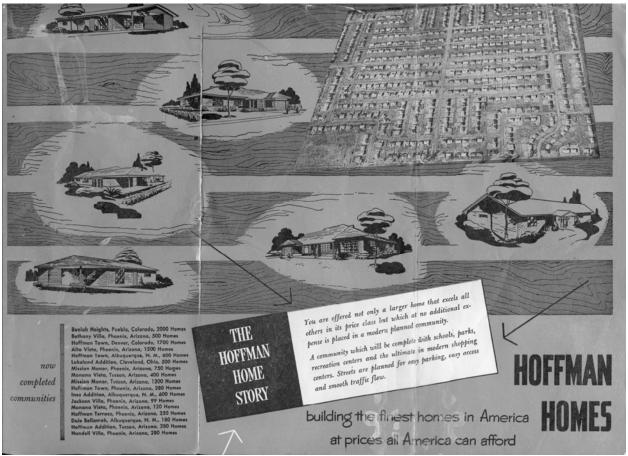
Figure 10.

Over a six year period beginning in 1947, Hoffman developed communities in Phoenix and Tucson, Arizona; Cleveland, Ohio; Albuquerque, New Mexico; Salt Lake City, Utah; Las Vegas, Nevada; Pueblo, Colorado; and Thornton, Colorado. Some of these communities were named "Hoffman Town," including the one that is the subject of this report, now known as Hoffman Heights. (Refer to Figure 10.) Hoffman later created Hoffman Estates in Cook County, Illinois, in 1954.

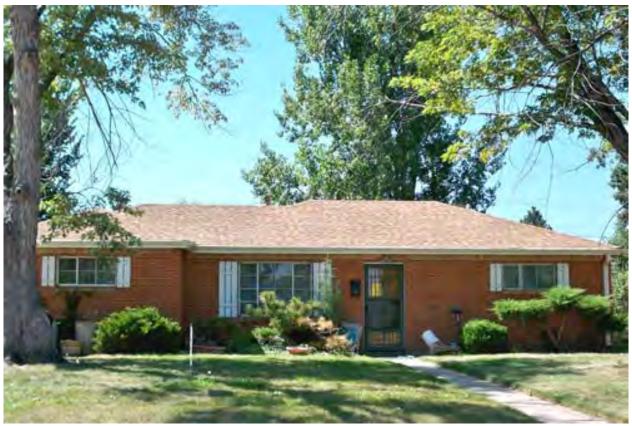
Figure 12.

Museum archives or other sources, one can assume from the study of the house model's front elevation that the entry door provides direct access to the living room, which is located in the center of the house and has a large window facing the street. The two smaller, horizontally-oriented windows at opposite ends of the façade provide natural light and ventilation for the bedrooms. (Refer to Figure 12.)

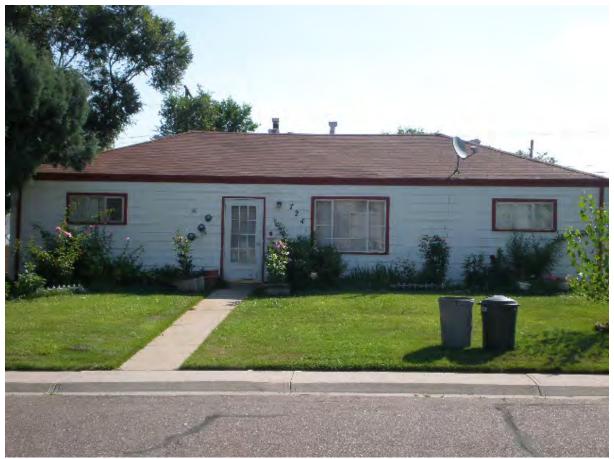
Figure 15.

windows at each end of the house. These houses were built on the 700 block of Uvalda Street and the 700 / 800 blocks of Vaughn, Victor, and Zion Street. (Refer to Figure 15.)

This "other" model at 724 Uvalda Street is an economy version of the Cosmopolitan Brick Model. The house has a hipped roof, original asbestos shingle siding, and steel casement windows. This house can be found in the Survey Log as one recommended to be intensively surveyed in the future.

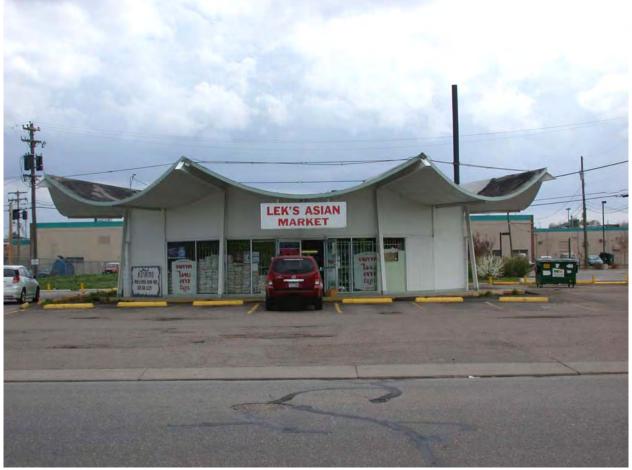
Figure 17.

The historic character of the residential portion of Hoffman Heights is enhanced by the multi-family housing, commercial development, and public buildings constructed as part of Hoffman Town. The churches, the elementary school, the library, the apartment building, the Hoffman Heights Shopping Center, and the individual commercial buildings along Del Mar Circle were constructed during the same time period as the houses. Research for this reconnaissance survey did not reveal whether Sam Hoffman was involved in their design or construction, but many of these buildings are architecturally significant and deserve further study. (Refer to Figure 17 below.)

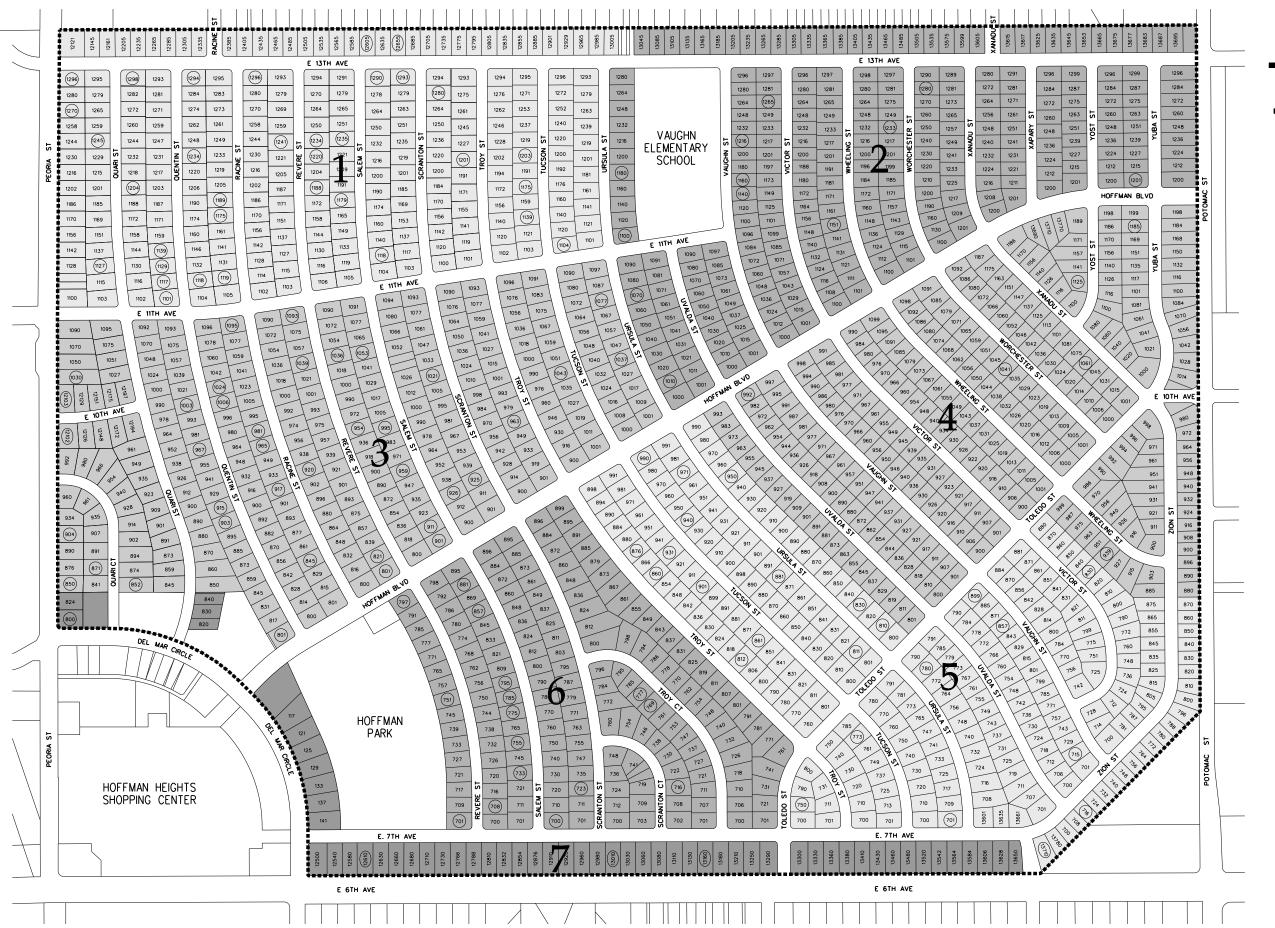
The following houses were found to be eligible for a future intensive-level survey. Their locations are shown on the Filing Map on page 36.

- 1 FIRST FILING NOV 13, 1950
- 2 SECOND FILING JULY 9, 1951
- 3 THIRD FILING OCT 2, 1951
- 4 FOURTH FILING FEB 18, 1952
- 5 FIFTH FILING AUG 28, 1952
- 6 SIXTH FILING OCT 28, 1952
- 7 SEVENTH FILING NOV 10, 1953
- DENOTES HOUSES
 DEEMED ELIGIBLE
 FOR FUTURE
 INTENSIVE SURVEY

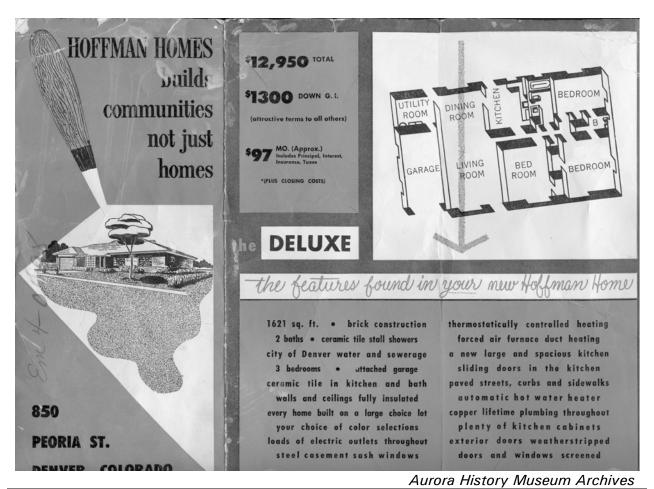
Figure 18.

This brochure for Hoffman Homes, which was apparently available at one of the model houses located at 850 Peoria Street, describes the Deluxe Brick Model. Note the drawing of the baseball bat on the left side of the brochure, which is a reminder that Sam Hoffman and "Hoffman Homes builds communities not just homes."
